## Waihee Fish Passage Project FINAL REPORT

Project Title: Waihee Fish Passage Project  
Grant/Cooperative Agreement No.: 122009J019  
Federal Agency: Department of the Interior Fish and Wildlife Services  
Project period: 10/1/2009 to 9/30/2013

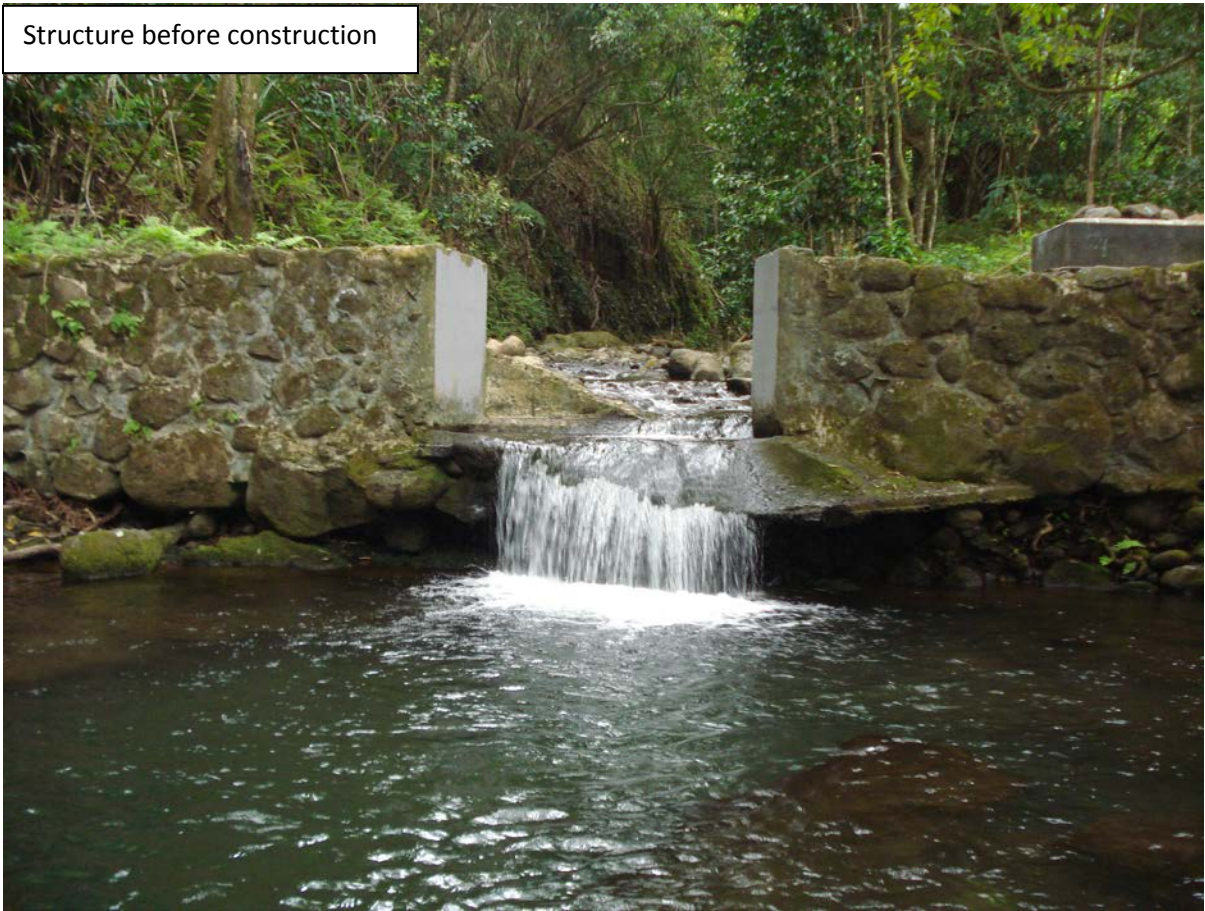
In 2007, WAI identified an abandoned stream gage structure on BWS property that appeared to be an obstruction to the migration of oopu in Waihee Stream. The structure was built in 1935 by the U.S. Geological Survey (USGS) to measure the amount of water in the stream. It was taken out of service in 1982 after a replacement gage was constructed downstream. Over the decades, the stream bed has widened causing the surface of the stream to lower and expose the base of the structure walls. The walls became undercut which created an overhang between the stream surface and the structure.

Structure before construction

A portion of the structure wall was repaired by inserting concrete-rubble masonry (CRM) including concrete (Portland cement and sand), and cobble and rocks from the adjacent upland area in a section of the undercut area. The work was done by hand. The concreted area was kept dry for 4 days. About 6" of the raised edge on the concrete overhang was removed, which had prevented water from flowing

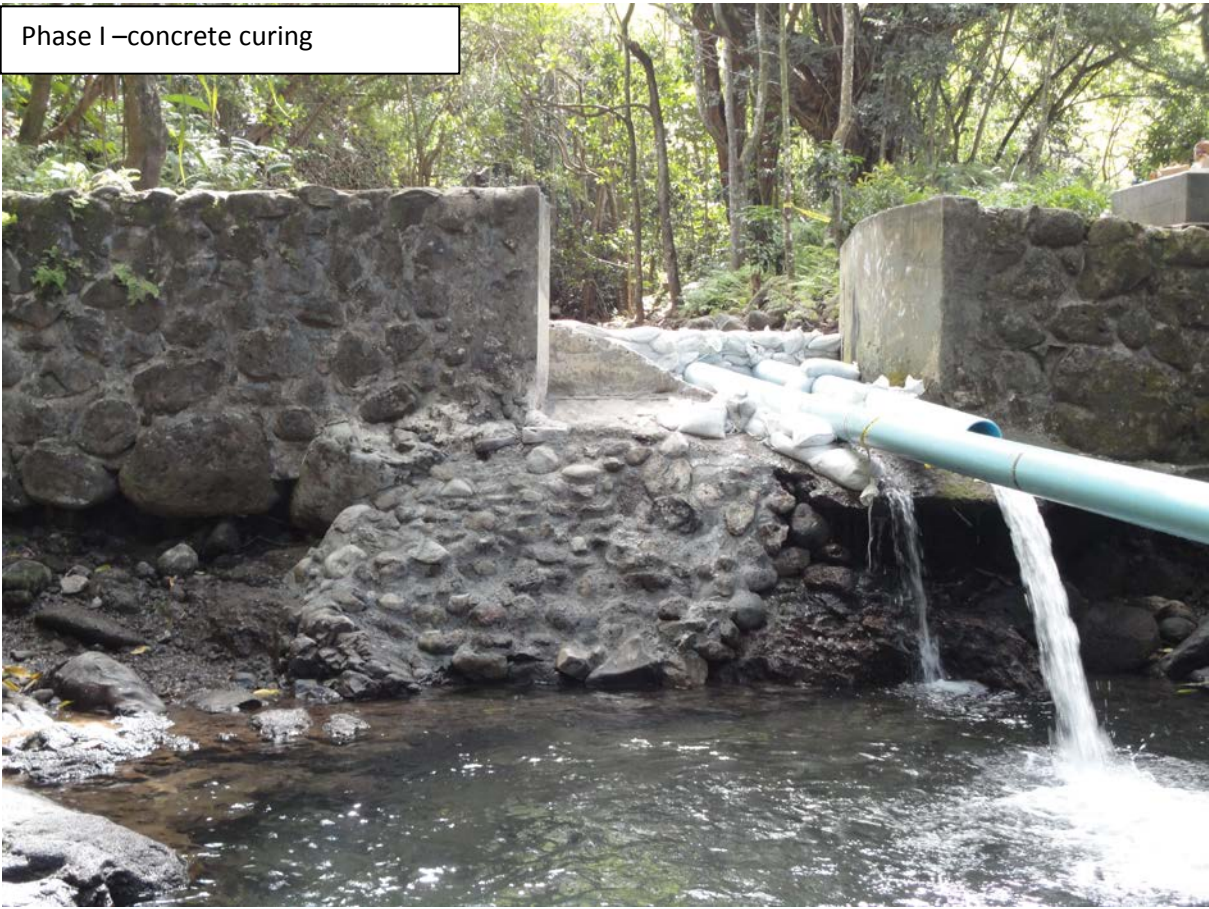
Phase I –concrete curing

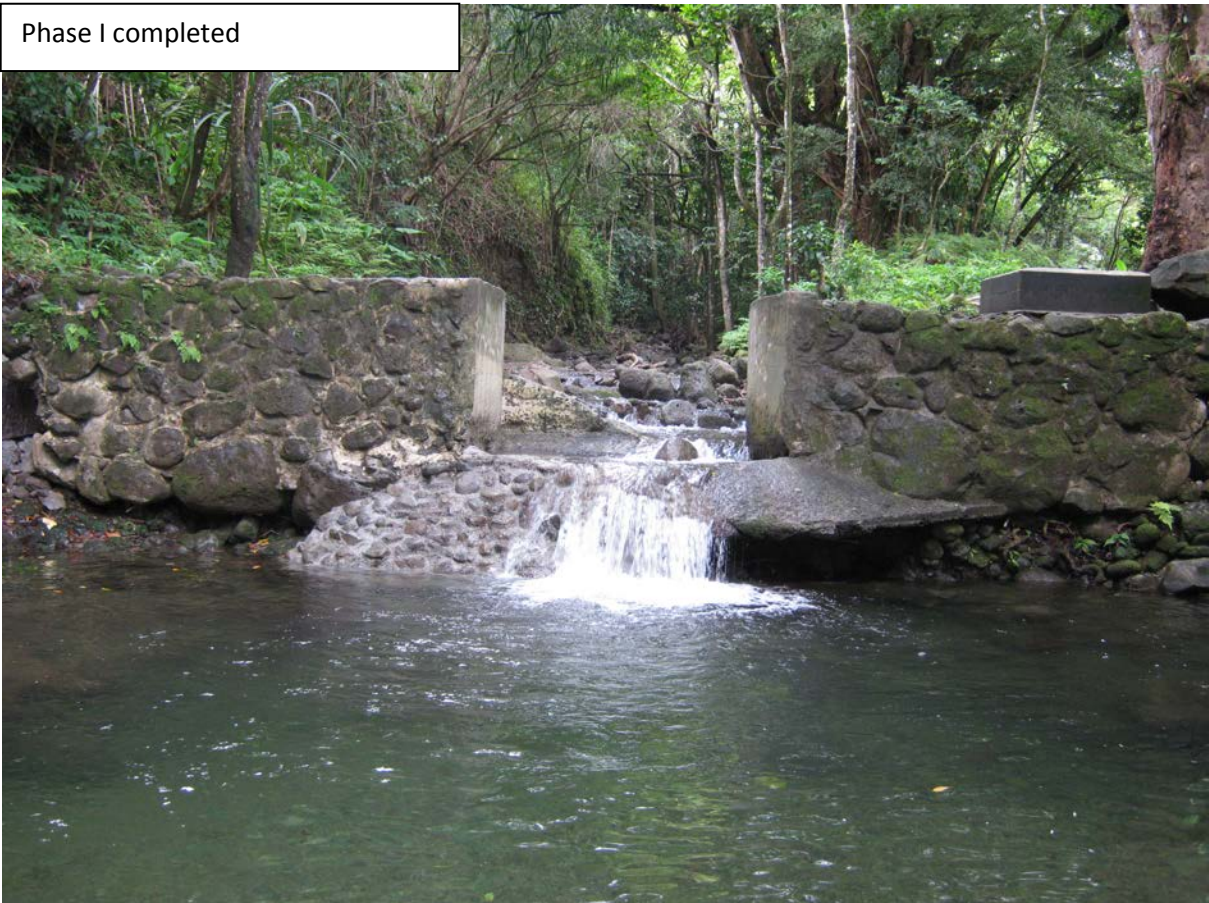
Phase I completed

down that side face of the structure wall. The concrete was removed using a hand held target saw with concrete diamond blade and hand tools. Debris and loose construction materials were removed from the construction area at the end of the construction day and disposed of at the BWS base yard. The construction and staging areas were cleaned at the end of each day of activity to remove any debris. The construction area was cleaned again prior to removing the sandbags and pipes.

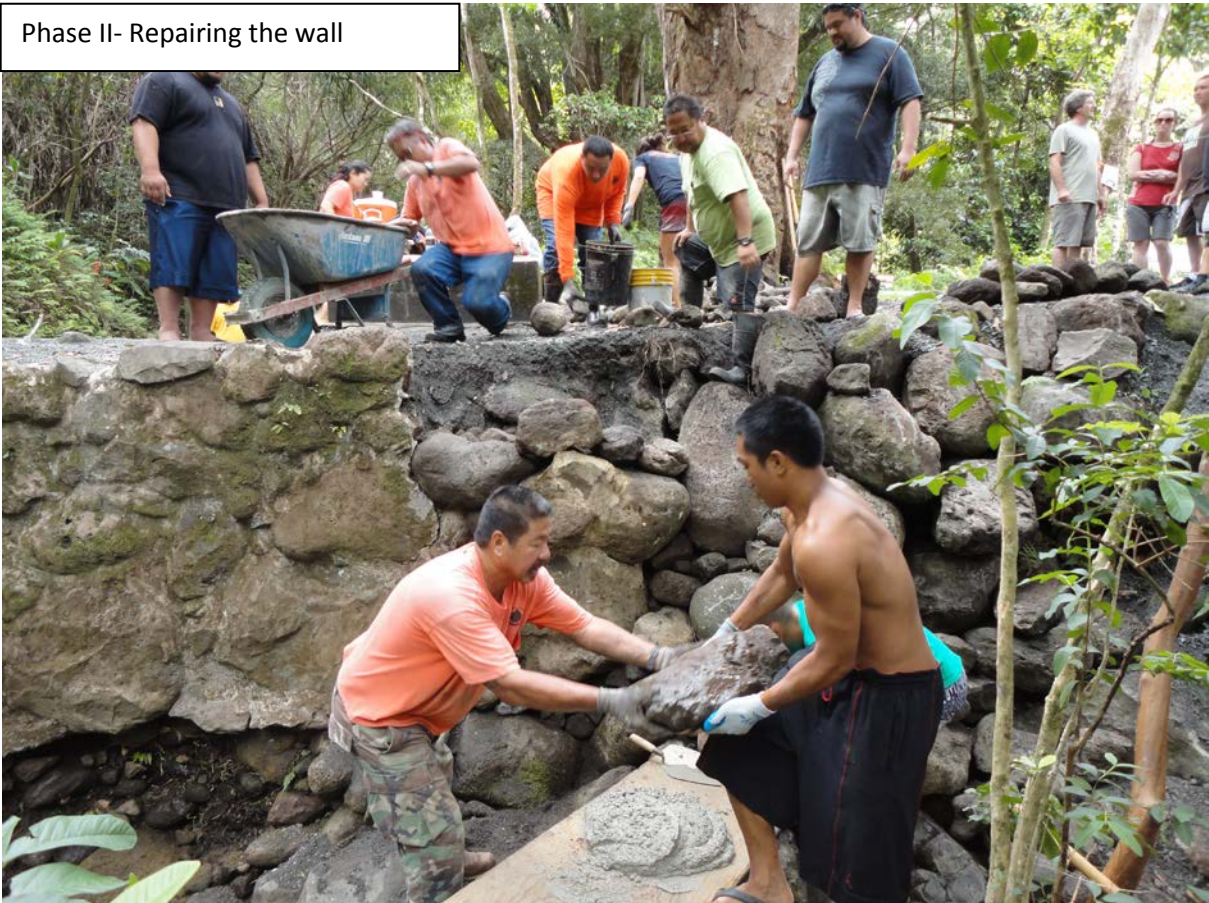
After assessing the Phase I work, WAI agreed that more work needed to be done to stabilize the structure. The surface of the chute/concrete lip area had deeply eroded pockets where water could wear a hole through the remaining concrete and the stream would by-pass the newly created fish passage. Also, there were concerns that the remaining undercut areas could compromise the stability of the structure.

Phase II- Repairing the wall

In June 2013, another phase of construction began to repair these areas starting with preparing area behind the top of the structure wall by filling in the eroded areas with crushed gravel. More locally sourced rocks were stockpiled there to fill in the remaining undercut areas of the wall. The same site preparation was done as in Phase I with the sandbags, pipes and plastic, and the water level in the pool below the structure was lowered. A hazard was identified in the structure wall- two large rocks on the top of the wall were loose and were barely secured to the surrounding rocks in the wall. The rocks were easily dislodged and the portion of the wall was repaired before work began on the undercut areas. The undercut areas were filled in with CRM and the eroded areas in the chute/lip area were filled with concrete with rocks embedded on the surface.

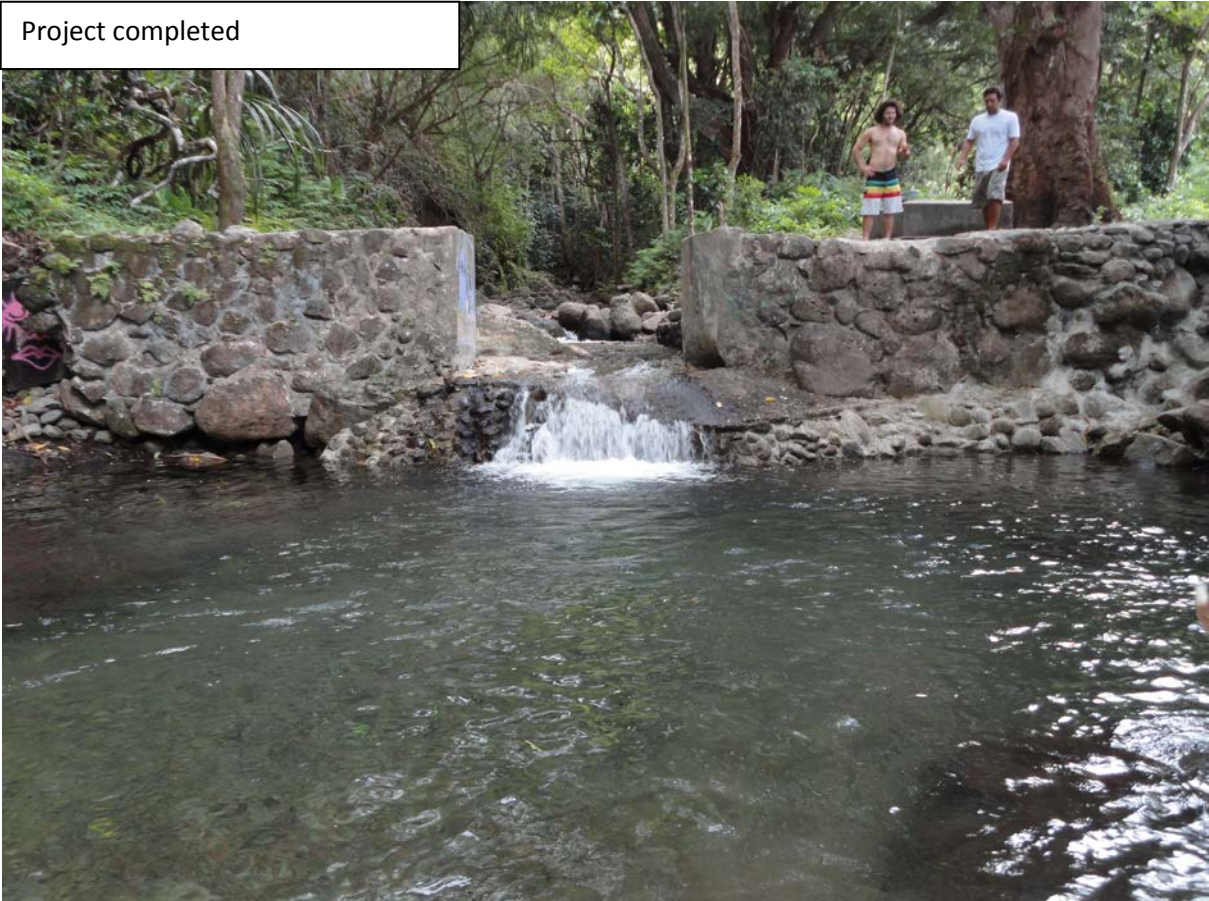
Due to scheduling conflicts, the eroded area on the left side of the structure (partially filled during Phase I) and the cement cap on top of the crushed gravel (behind the structure walls) were not completed. Work to those areas may be done through the WAI partnership if it is deemed necessary.

Project completed
